2023 Turkey Earthquake Virtual Report on Geotechnical Impacts

Report Date: 2/9/2023

Geotechnical Extreme Events Reconnaissance (GEER) Association

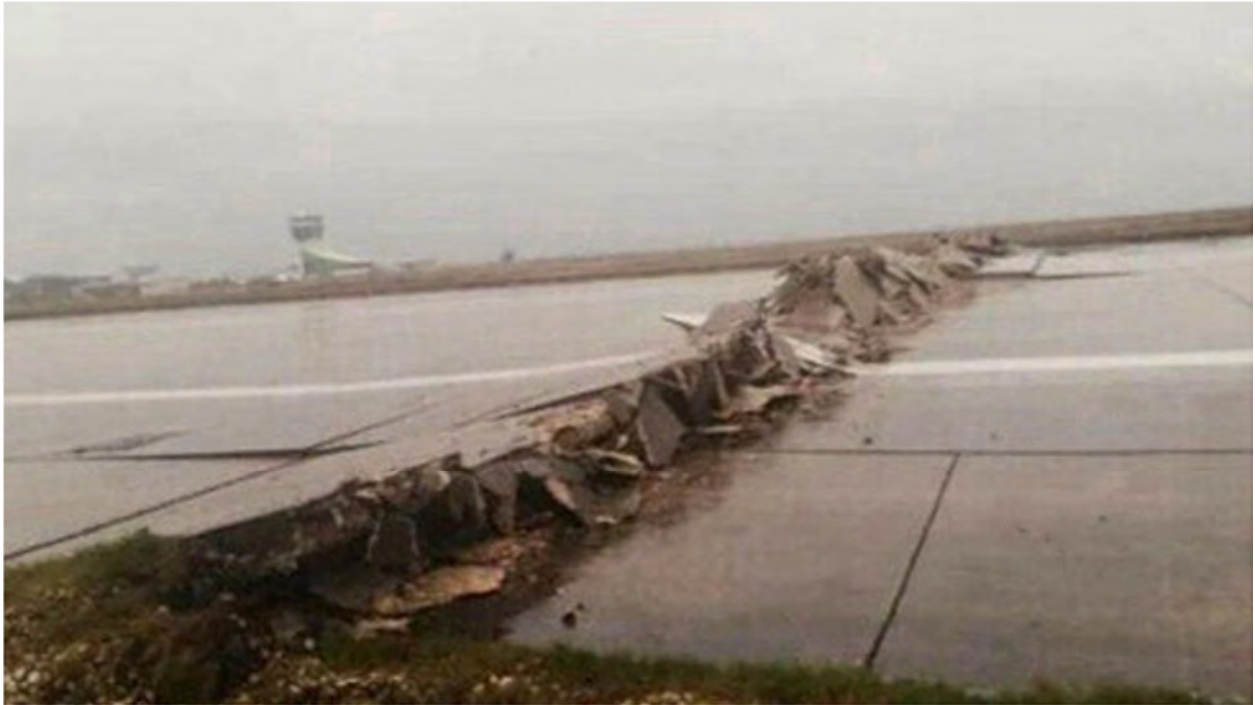
Figure 2: Damage to Hatay Airport runway
(<https://www.ozgurkocaeli.com.tr/haber/13964829/hatayda-deprem-sonrasi-havaalani-pisti-yikildi>)

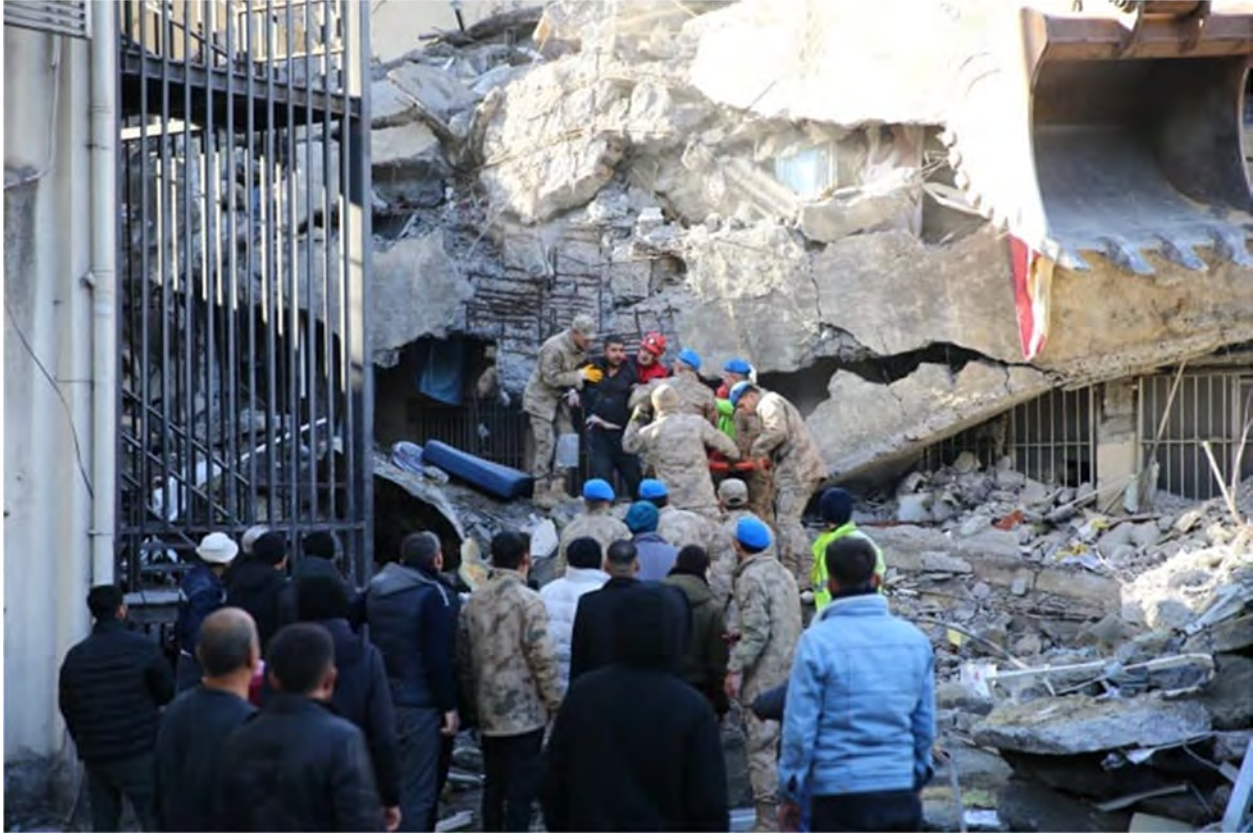
Figure 3: Collapsed state hospital in Iskenderun, Hatay (<https://www.diken.com.tr/hastane-nasil-yikilir/>)

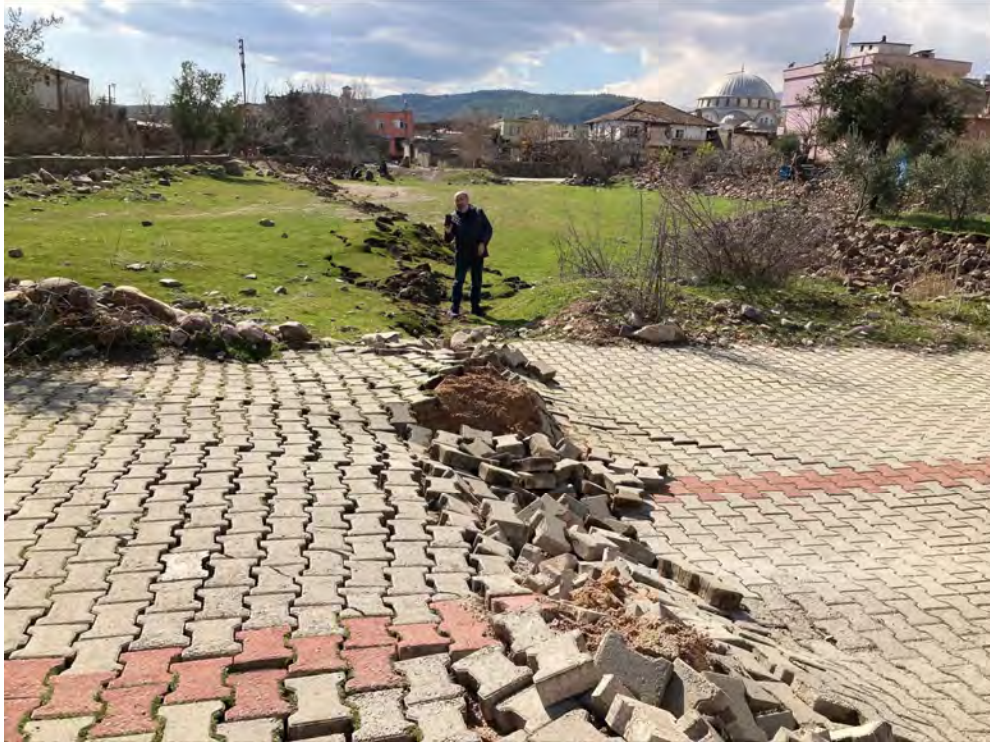
Figure 17: Surface rupture observed in residential neighborhood near Hessa (Source: <https://twitter.com/ziyadin/status/1623288689894871046/photo/1>)

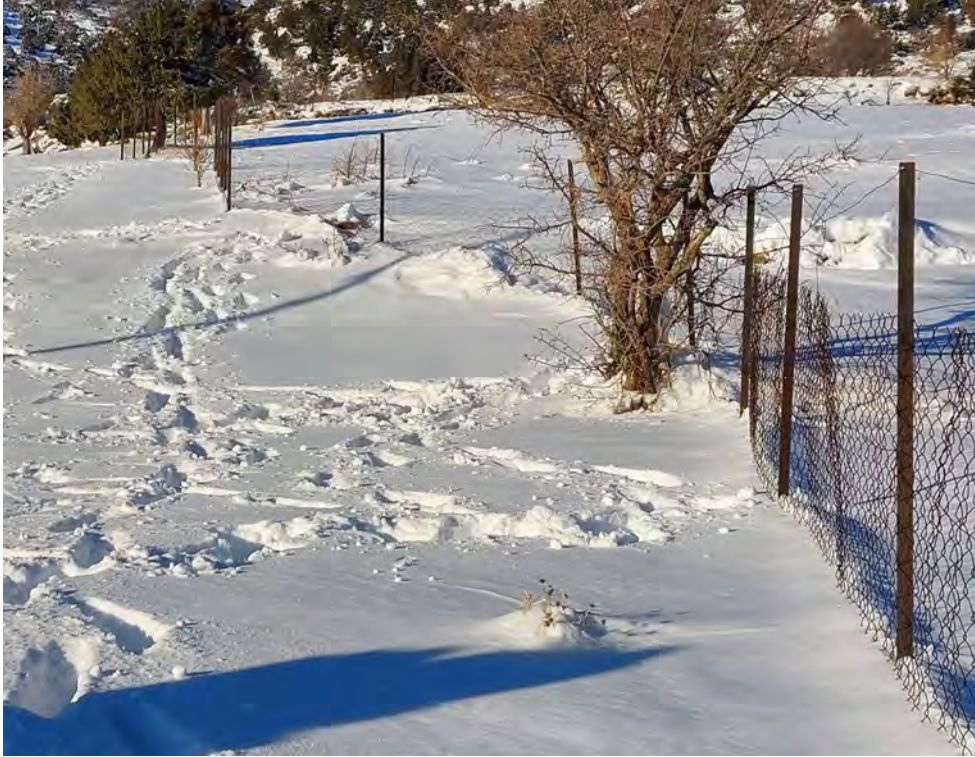
Figure 19: Ground displacement in Kahramanmaraş measured by fence offset of 6.7m
(Source: Twitter Taylan SANÇAR;
<https://twitter.com/tsancar/status/1623698495730339840/photo/1>)

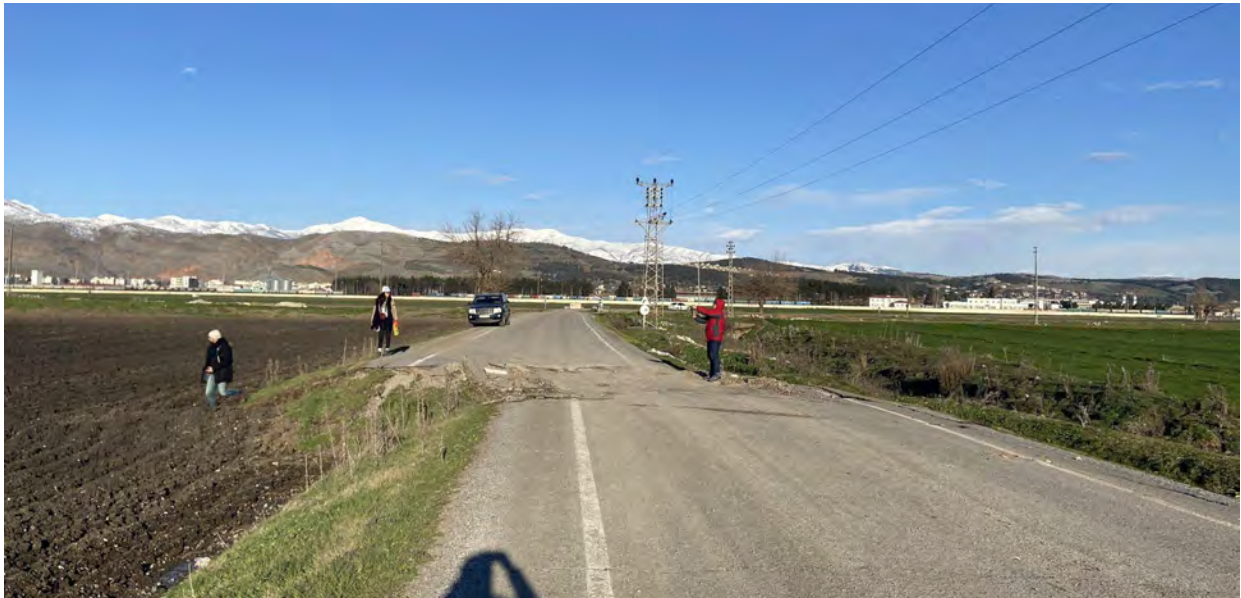
Figure 20: Road damage in Kahramanmaraş/Türkoğlu. 3.3m of displacement (Source: Twitter Cengiz Zabci). <https://twitter.com/CengizZabci/status/1623236487687929857/photo/1>

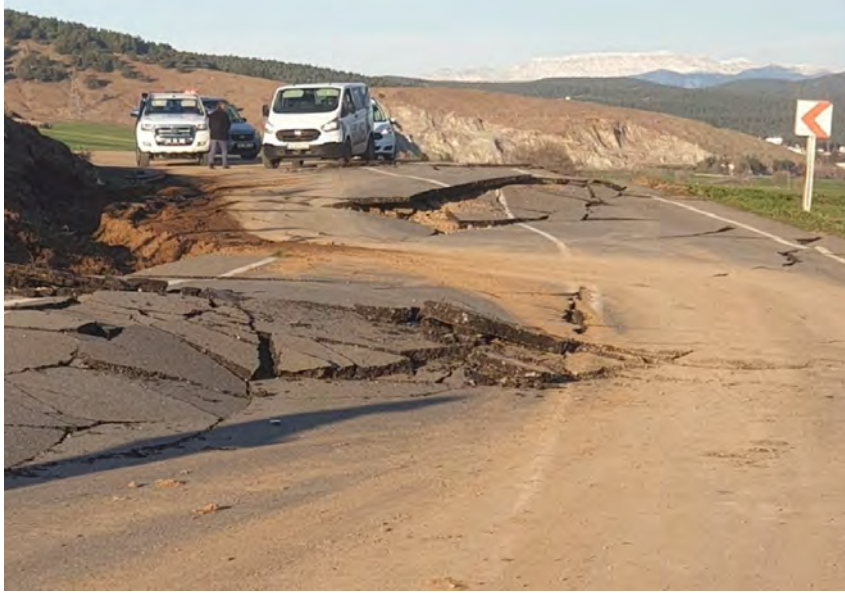
Figure 21: Road damage in Tevekkeli, Tevekkeli Village Road, 46090. (Source: Twitter Zeliş; https://twitter.com/Panthalassa_Z/status/1623237597752352769)

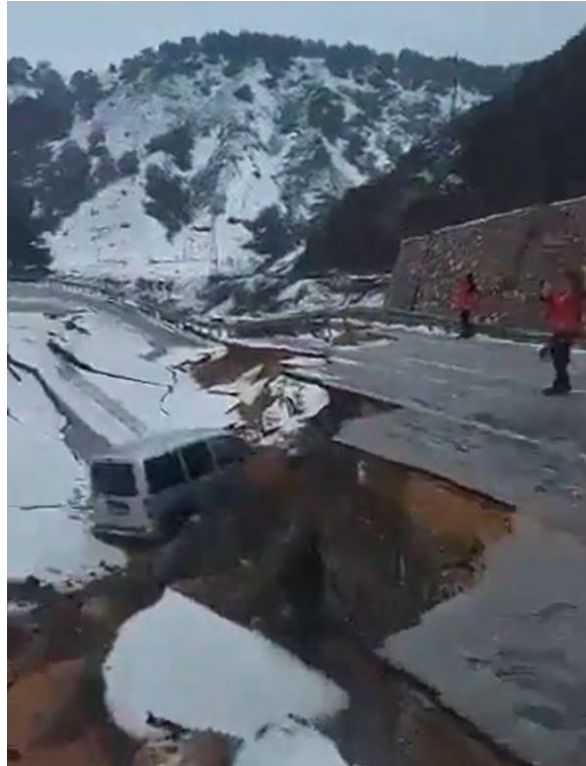
Figure 22: Lateral flow landslide on the road between Adana and Gaziantep (Source: Twitter video Sokagin Sesi Gazetesi; <https://twitter.com/sokaginsesigaz1/status/1622689001332215853>)

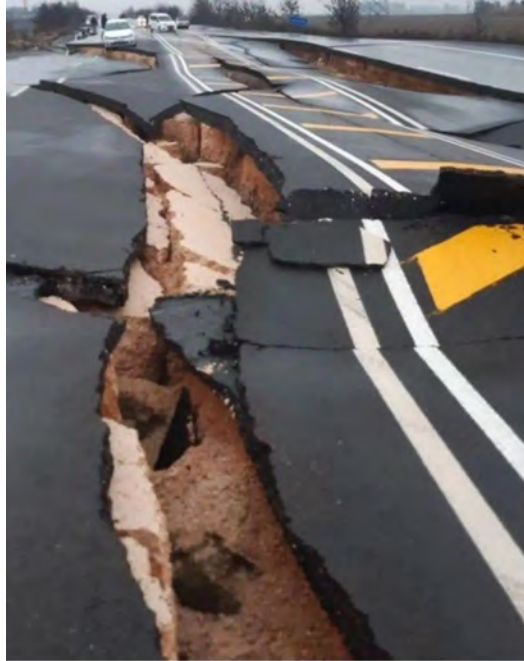
Figure 23: Road in Hatay, Turkey completely split open. (Source Video: Video <https://twitter.com/porcumali/status/1622594257176469506>)

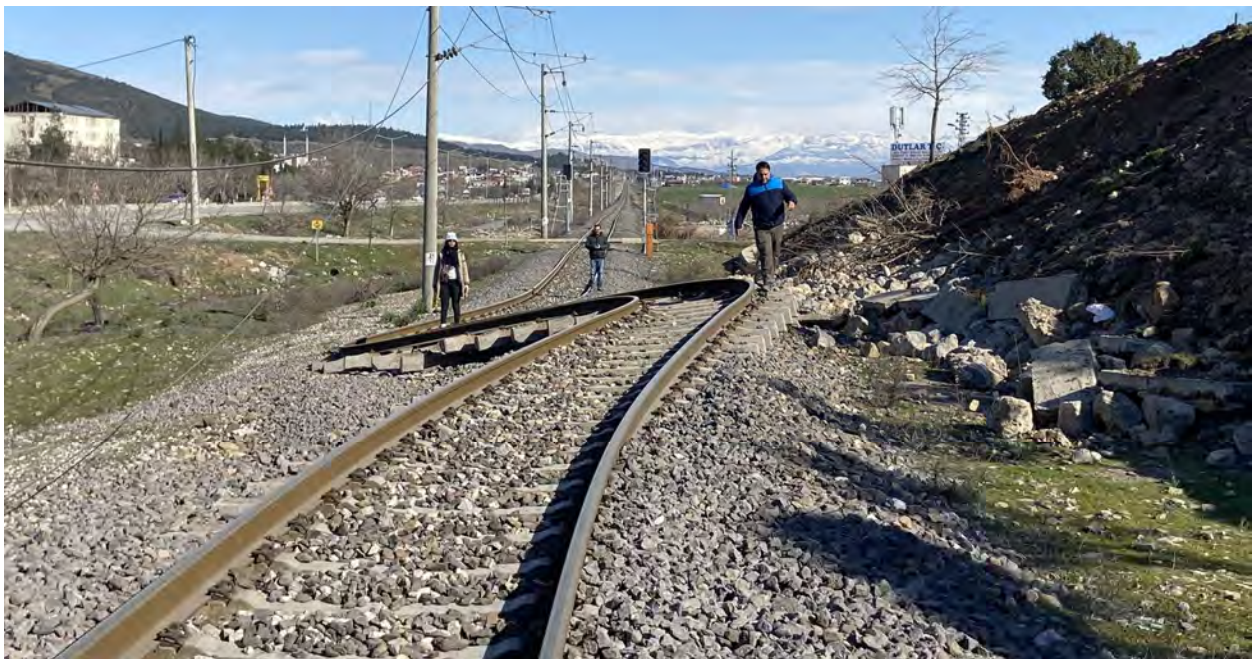
Figure 24: Surface displacement in Şekeroba highlighted by rail displacement (Source: Twitter Cengiz Zabcı <https://twitter.com/CengizZabcı/status/1623236454926229504/photo/1>)

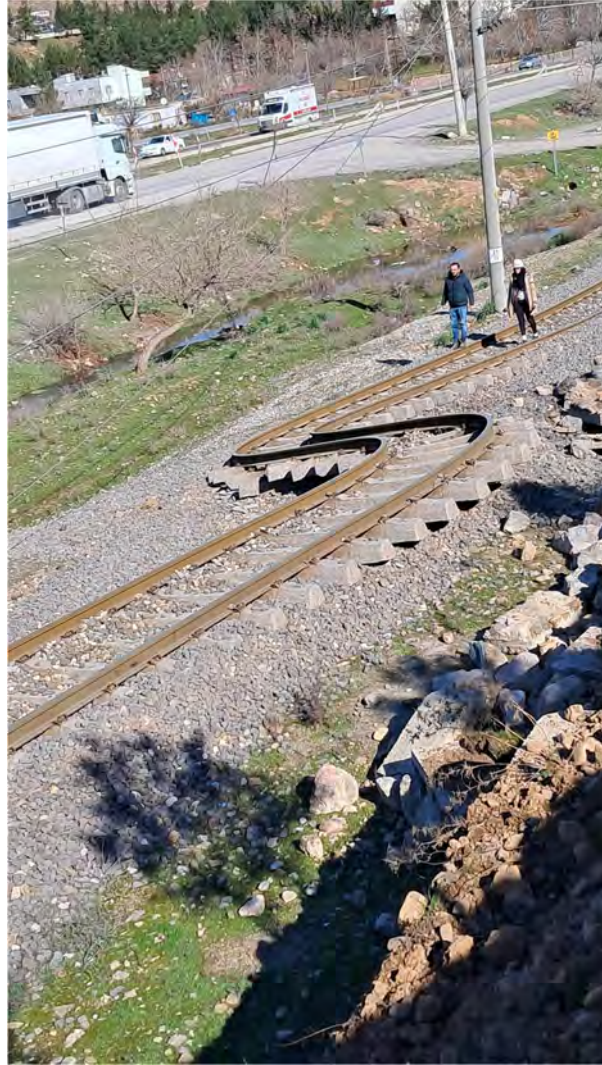
Figure 25: Surface displacement in Şekeroba highlighted by rail displacement (Source: @akyuz24 on Twitter)

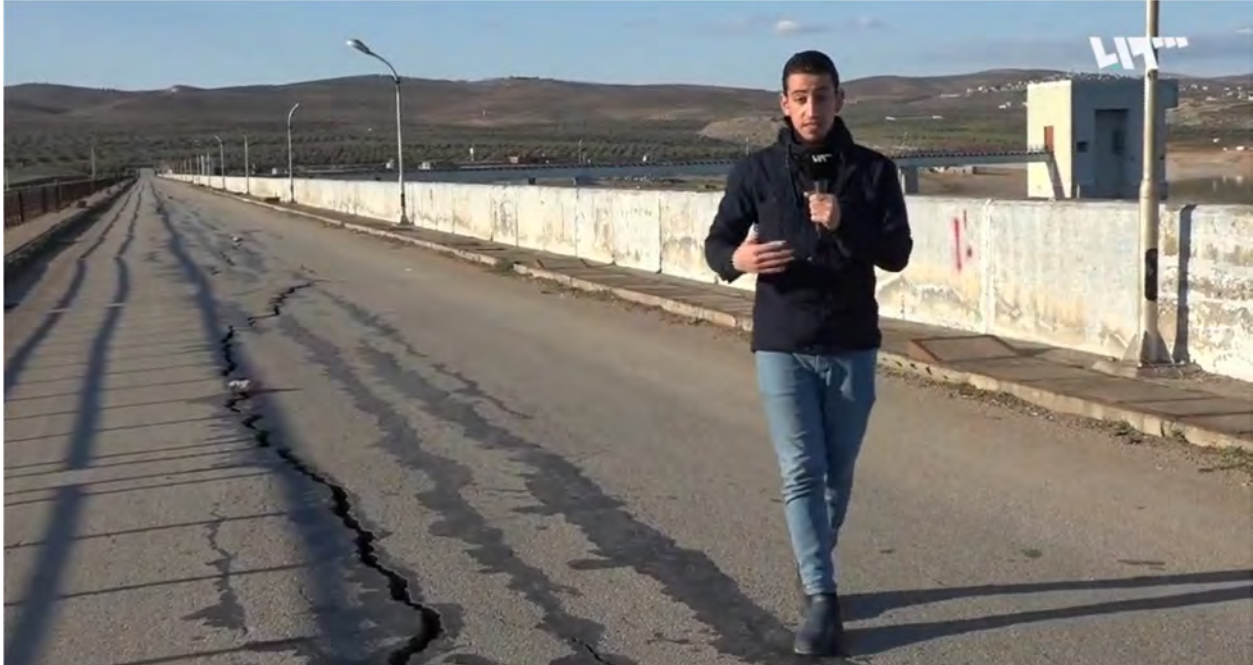
Figure 27: Cracking in the Afrin Dam (Source: <https://twitter.com/Hibakarm/status/1623723294686838784>)

The earthquake sequence resulted in the cracking of the Afrin Dam and the subsequent flooding of a downstream Syrian enclave, al-Tlul. There have been no further reports of flooding or damage, and no evacuation notices have been sent. Additionally, the Ataturk dam, the third largest dam in the world, has been cleared of any damage or impacts resulting from the earthquakes.

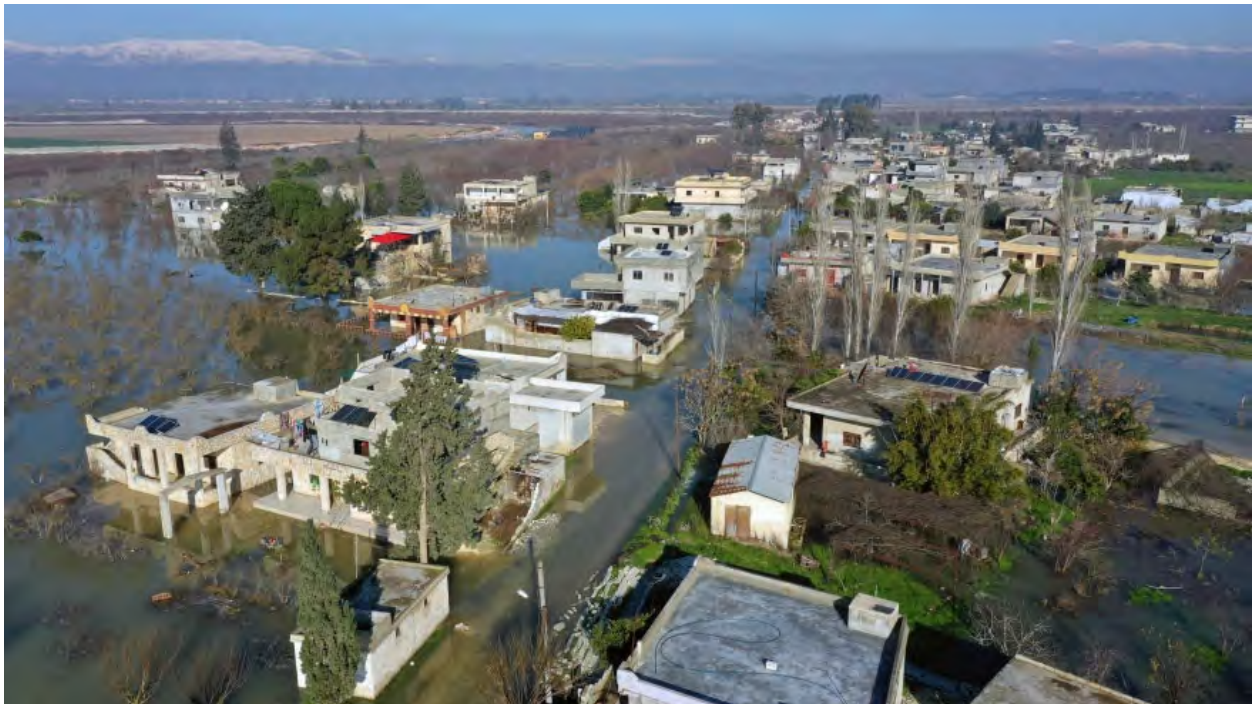
Figure 28: Aerial view of the al-Tlul village, where damage to the Afrin dam led to flooding (Photo Credit: AP Photo/Ghaith Alsayed).

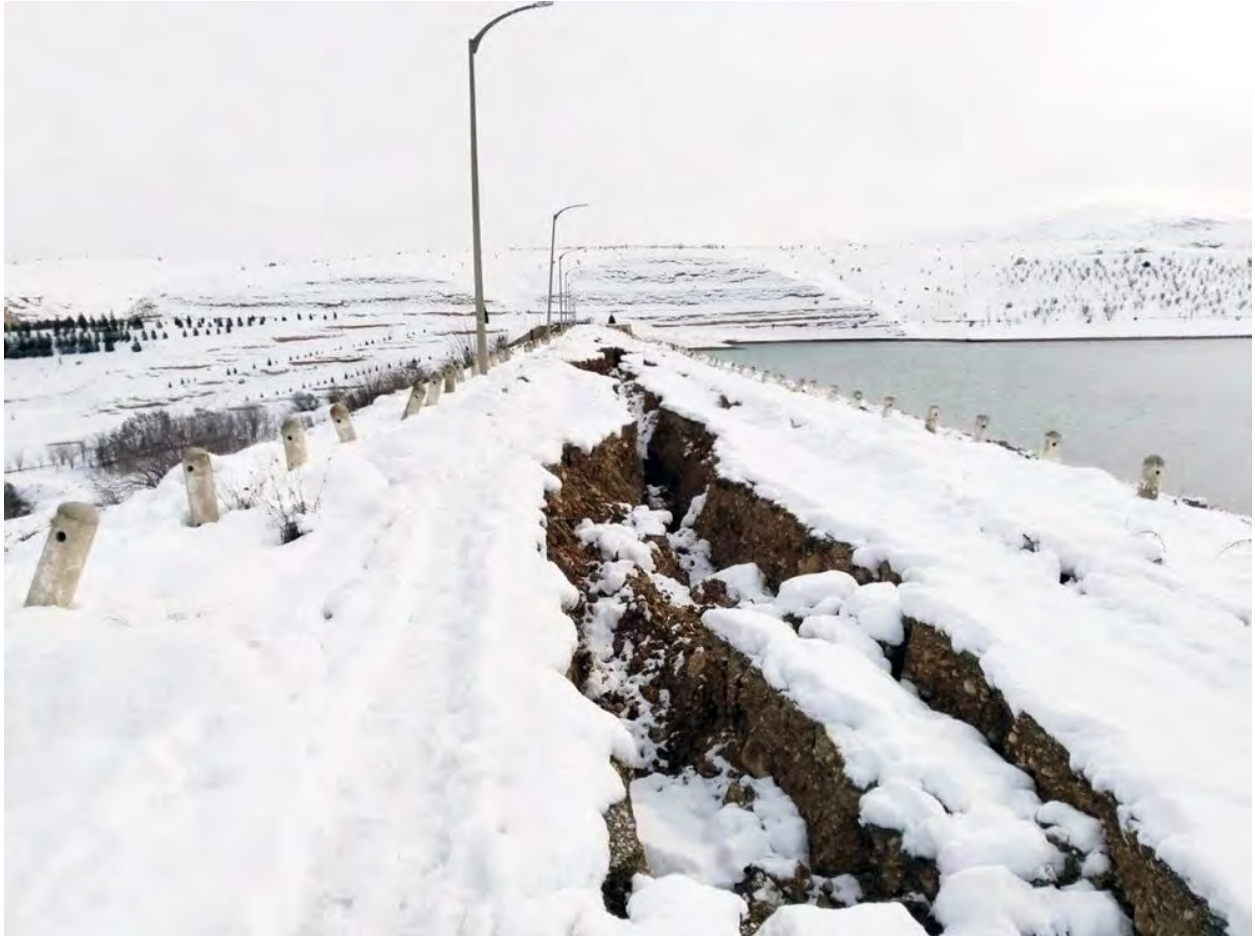
Figure 29: Cracking damage observed in the Sultansuyu Dam (Source: <https://www.ntv.com.tr/galeri/turkiye/govde-aksinda-catlaklar-olusan-malatyadaki-sultansuyu-baraji-tahliye-ediliyor,xxRN92Huy0iiG0tyCNU4fA/aimTJcX5X0egL7OUo5ez0Q>)
