2023 Turkey Earthquake Virtual Report on Geotechnical Impacts

Report Date: 2/9/2023

Geotechnical Extreme Events Reconnaissance (GEER) Association

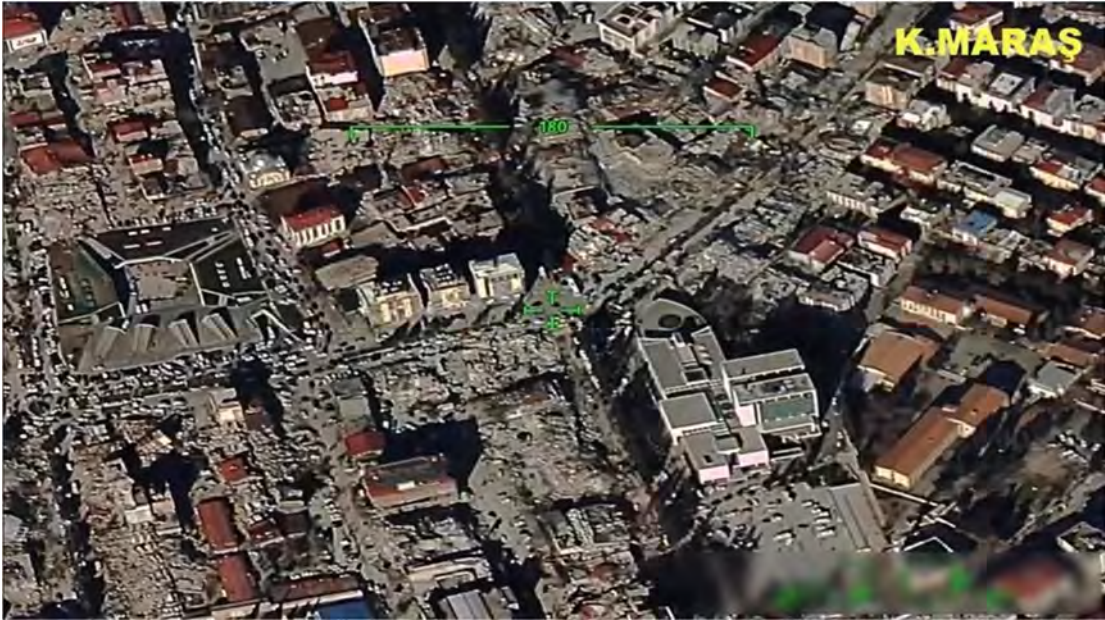
Figure 4: An image taken by UAV from Kahramanmaras
(<https://www.milliyet.com.tr/galeri/buyuk-afette-ucuncu-gun-deprem-bolgesinde-zamana-karsi-yaris-6900343/1>)

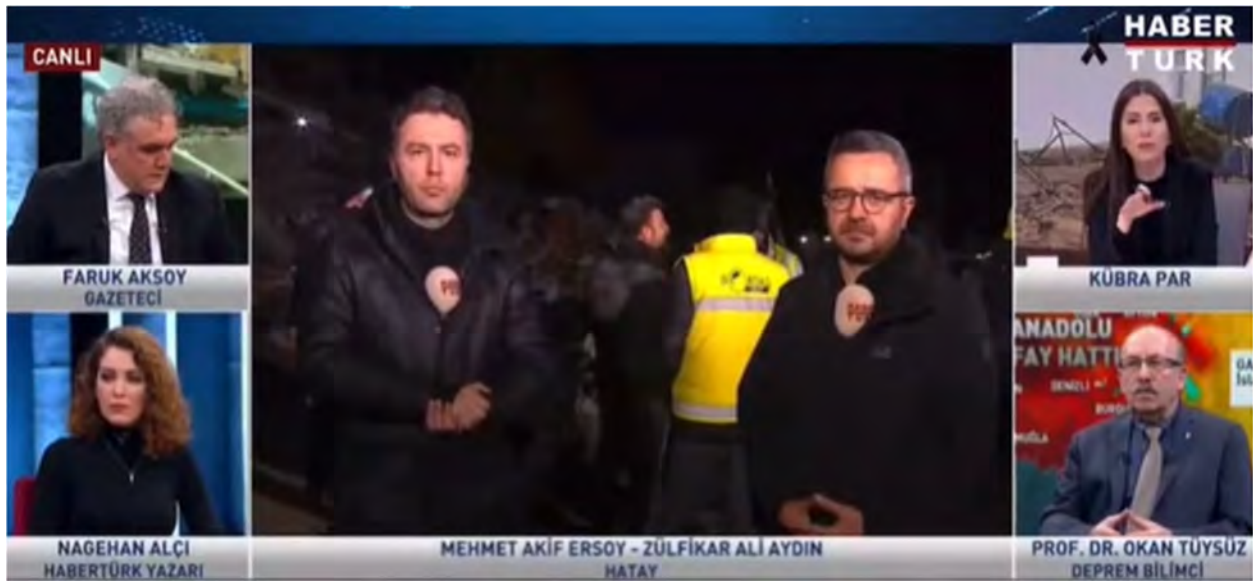
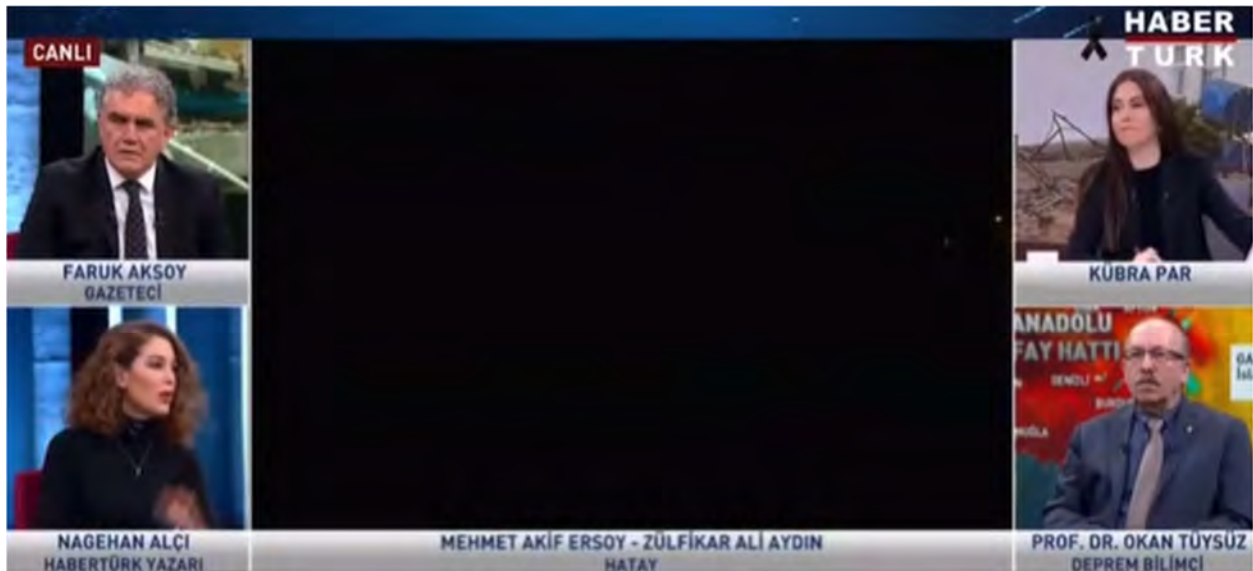
One reporter showed the lack of lighting during the search and rescue on the second day of the earthquake in Hatay. The only lighting rescuers had in the field was the lighting of the camera crew.

Figure 5: A live Turkish news broadcast showing no lighting in the field (February 7)

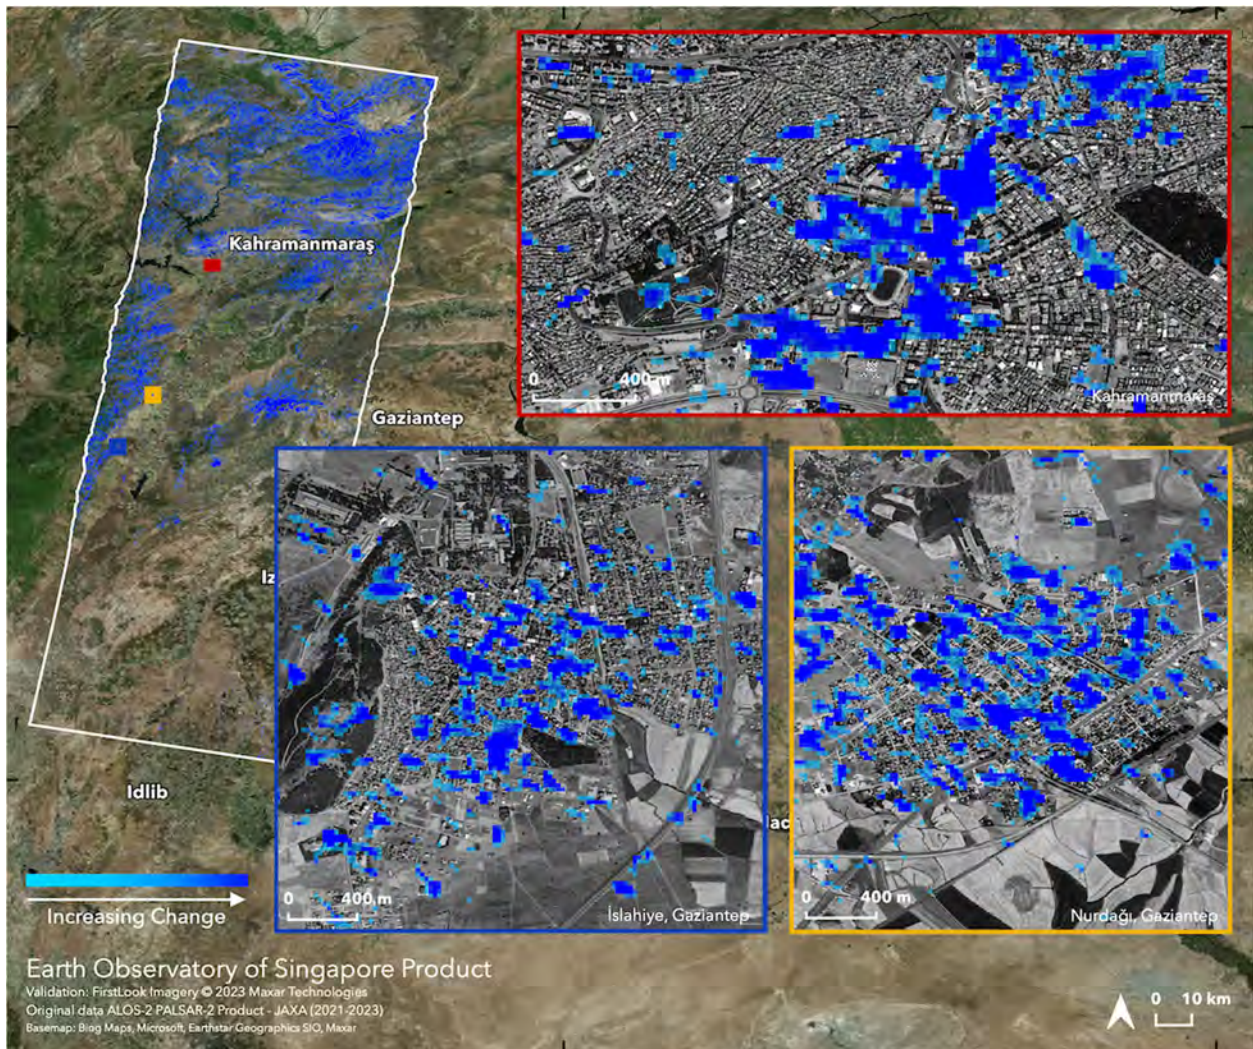
One of these products is the Damage Proxy Map (DPM), which highlights the areas that likely suffered damage after the earthquake. This dataset was computed using synthetic aperture radar (SAR) images captured by the ALOS-2 satellite before the event (from April 2021 to April 2022), and after the event (February 8 2023).

Figure 11: Damage Proxy Map (Source: Earth observatory of Singapore)

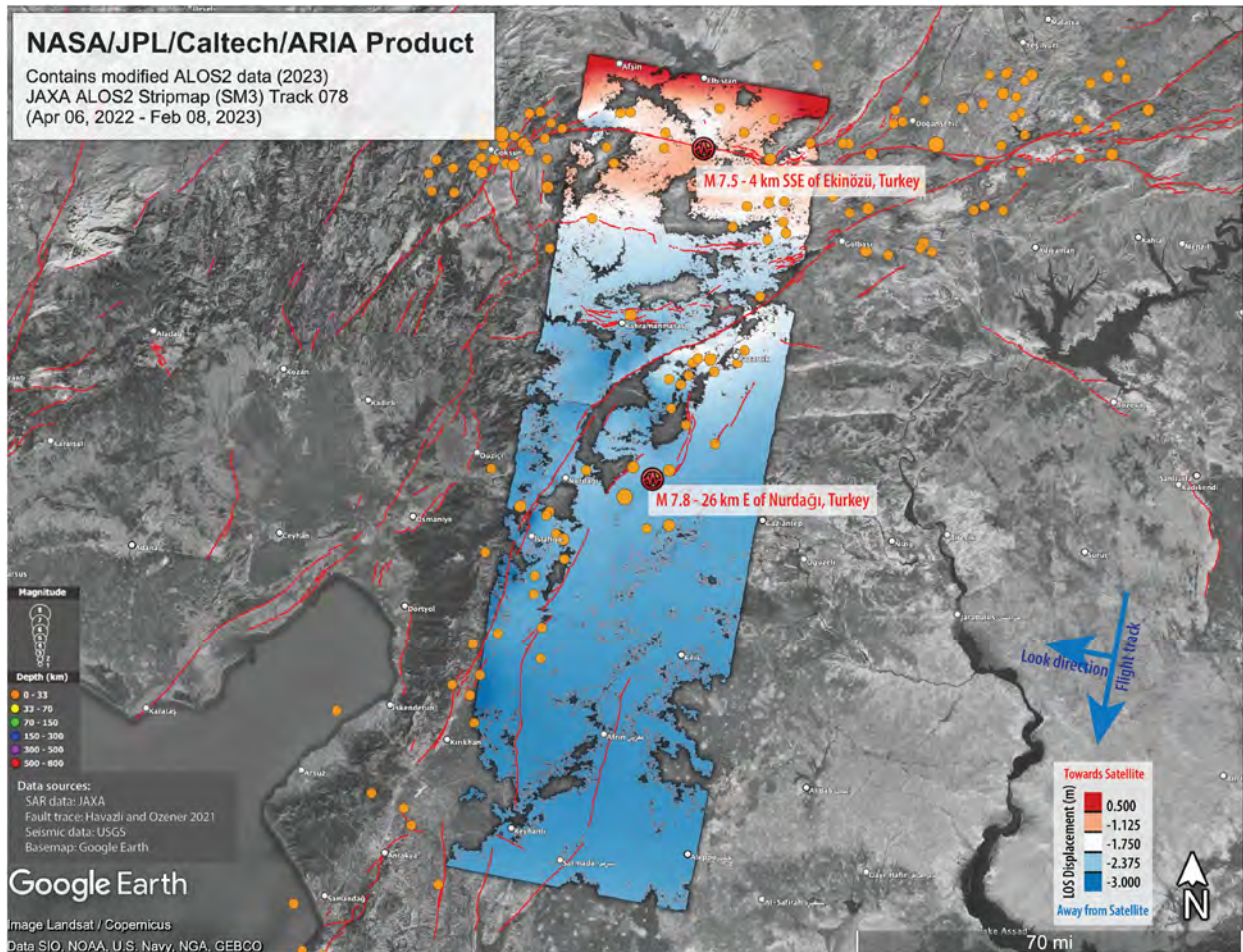
NASA JPL Laboratory has generated Stripmap displacement maps by computing the interferometric difference (interferogram or interferometric SAR) and pixel offset tracking between the post-event image acquired on February 8, 2023 with a pre-event image acquired on April 6, 2022, on the ALOS-2 descending (satellite moving south) track 78.

Figure 12: Preliminary dataset on surface displacement (Source: NASA JPL)

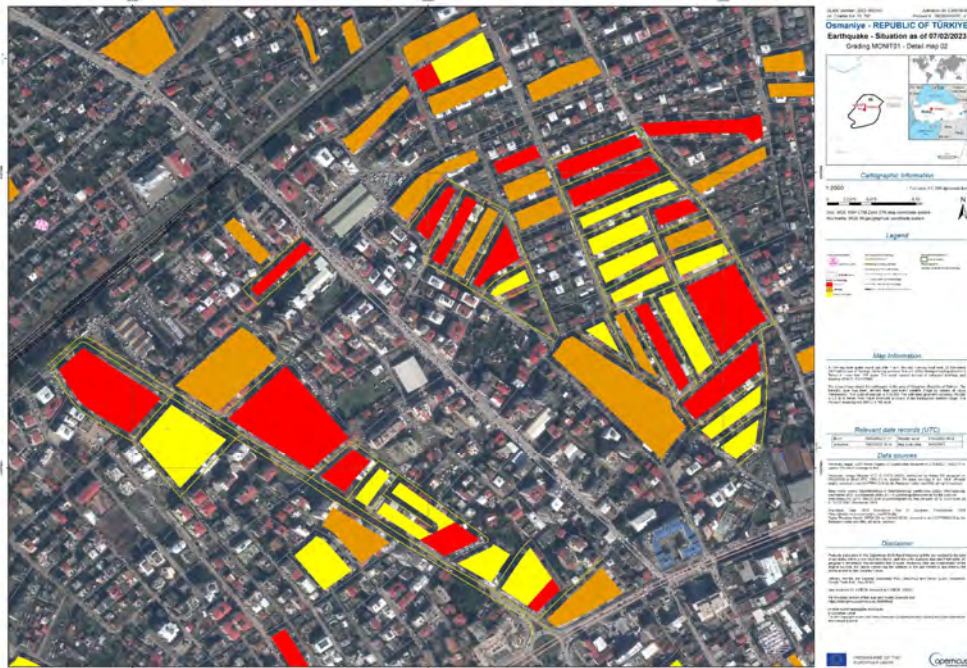
For each of these areas, satellite imagery is used to manually identify damage to infrastructure. The next figure shows the damage grading product for Osmaniye (Turkey) where red areas represent Destroyed, orange Damaged, and yellow Possibly Damaged. A larger grading product was released for the city of Kahramanmaraş.

Figure 14: Damage grading in Osmaniye (Source: Copernicus EMS)
https://emergency.copernicus.eu/mapping/ems-product-component/EMSR648_AOI06_GRA_MONIT01_r1_RTP02/1

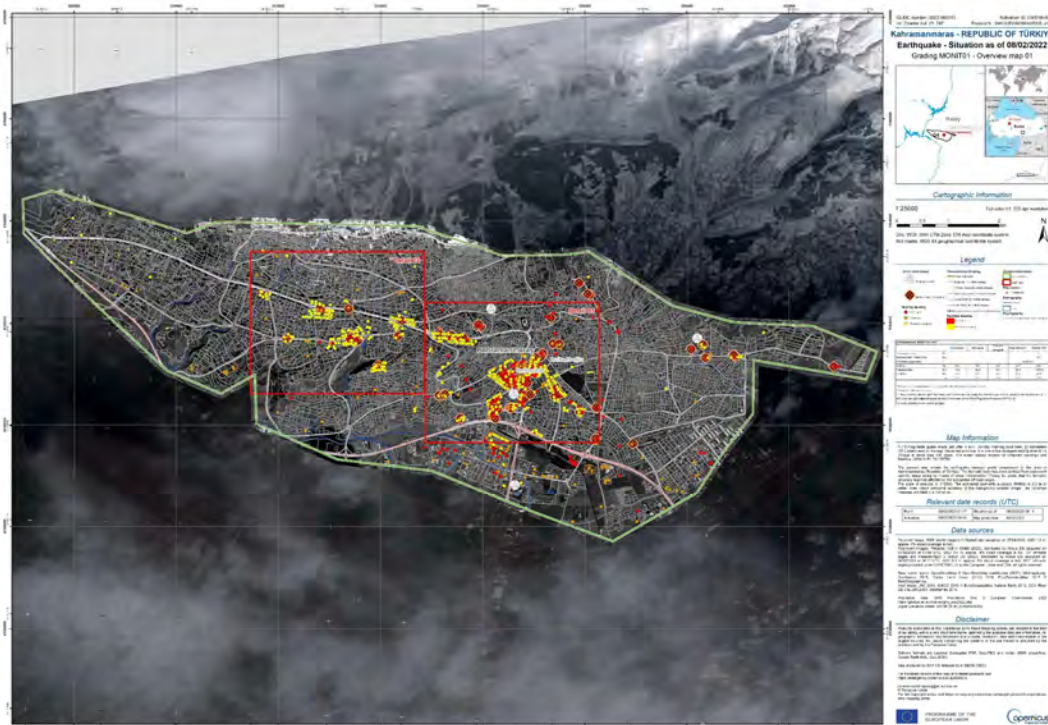
Figure 15: Damage grading in Kahramanmaraş (Source: Copernicus EMS)
https://emergency.copernicus.eu/mapping/ems-product-component/EMSR648_AOI04_GRA_MONIT01_r1_RTP01/1

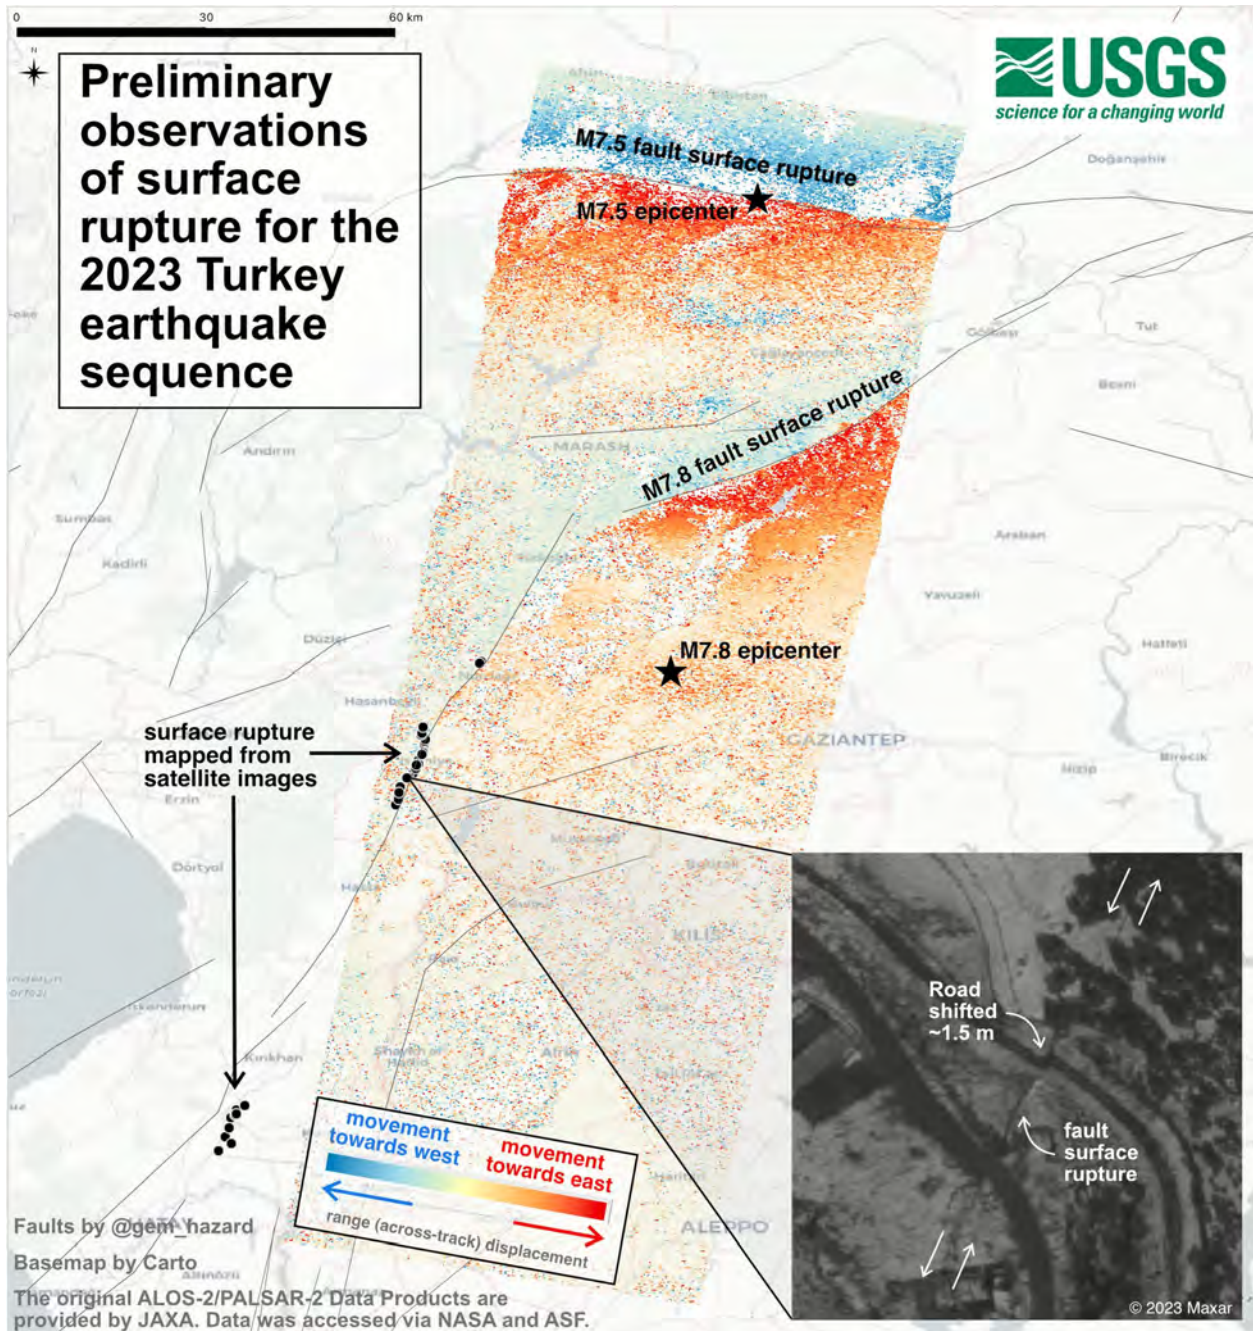
Figure 16: Surface Rupture estimation from satellite imagery (Source: @USGS_Quakes on Twitter)

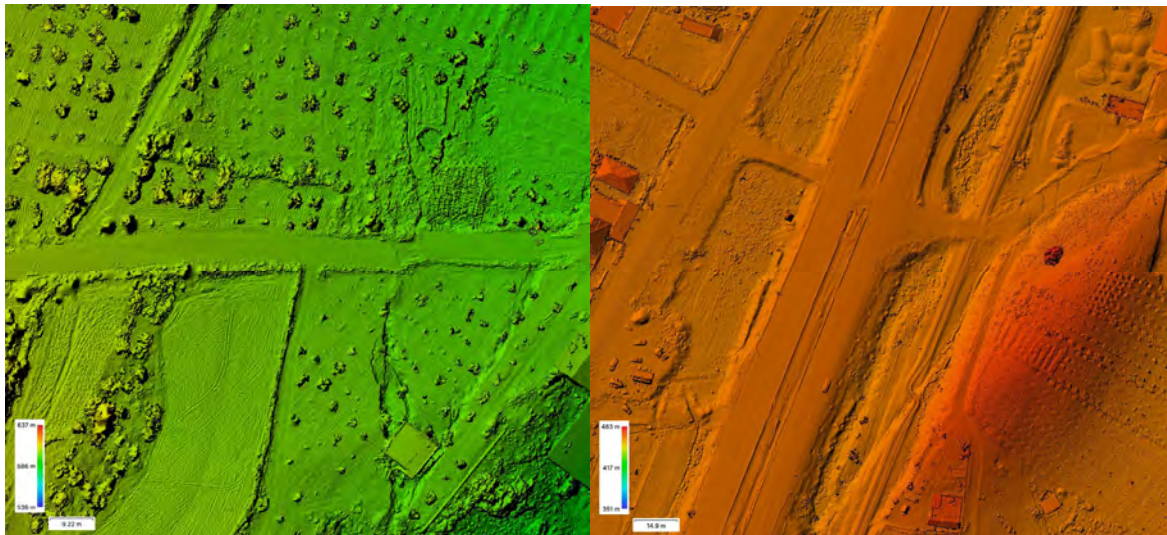
Professor Cengiz Zabcı from Istanbul Technical University (ITU) generated some of the first UAV-based digital Surface Models (DSMs) of the surface rupture.

Figure 18: UAV-based Digital Surface Model in Şekeroba, Turkey (Source: Twitter Cengiz Zabcı <https://twitter.com/CengizZabcı/status/1623569420554493953>)

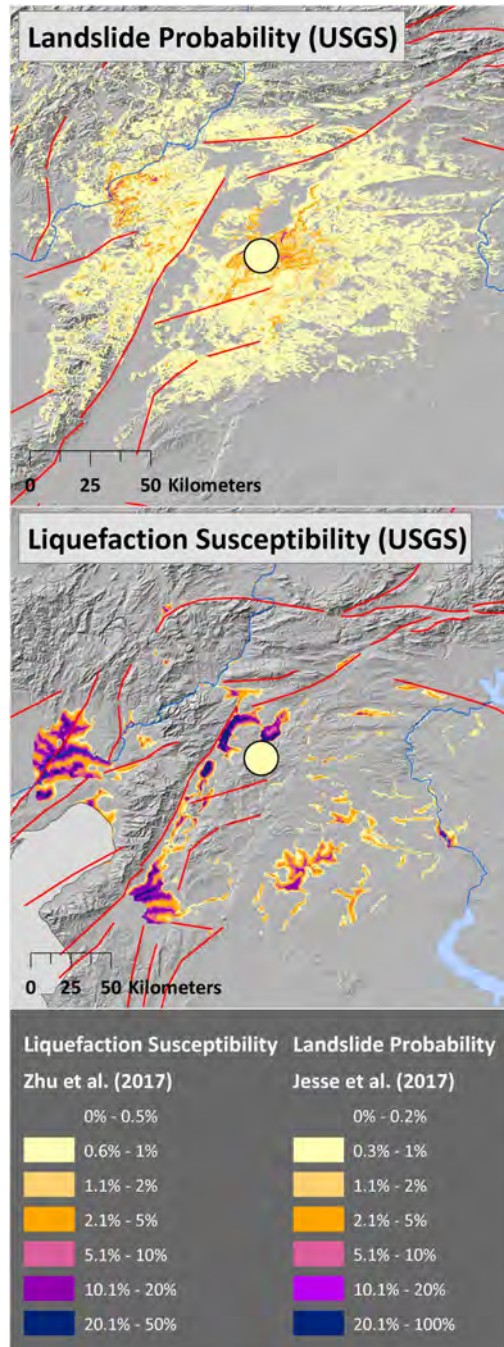
Figure 26: Landslide and Liquefaction Susceptibility Maps (USGS; Zhu et al., 2017; Jesse et al., 2017)

There have been no reports of liquefaction to date, although more thorough investigation will be needed to determine failure mode of many structure. Field investigations will be needed to determine the severity of liquefaction induced building settlements and failures.

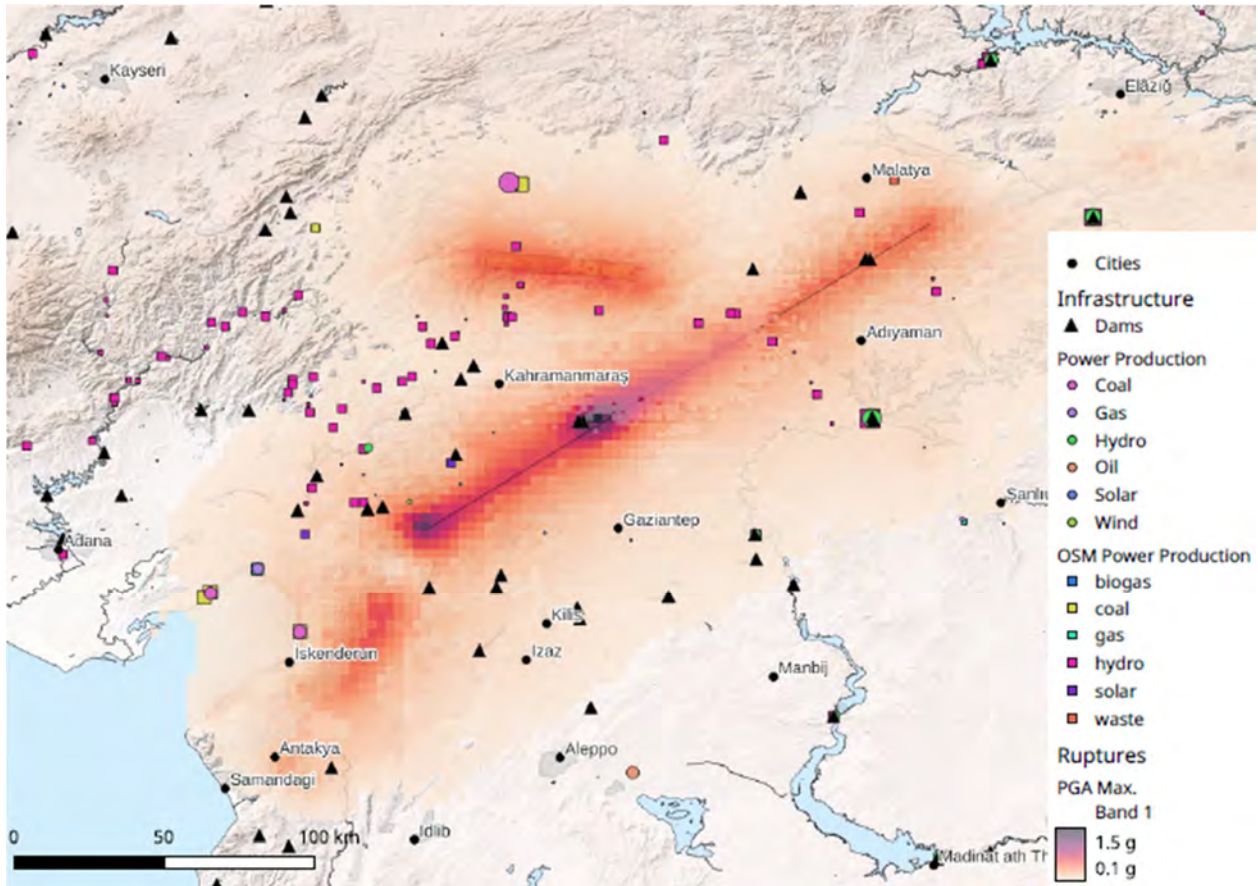
Figure 30: Locations of dams and critical power infrastructure assets in the affected region
(Source: Albert Kottke & Ozgur Kozaci)

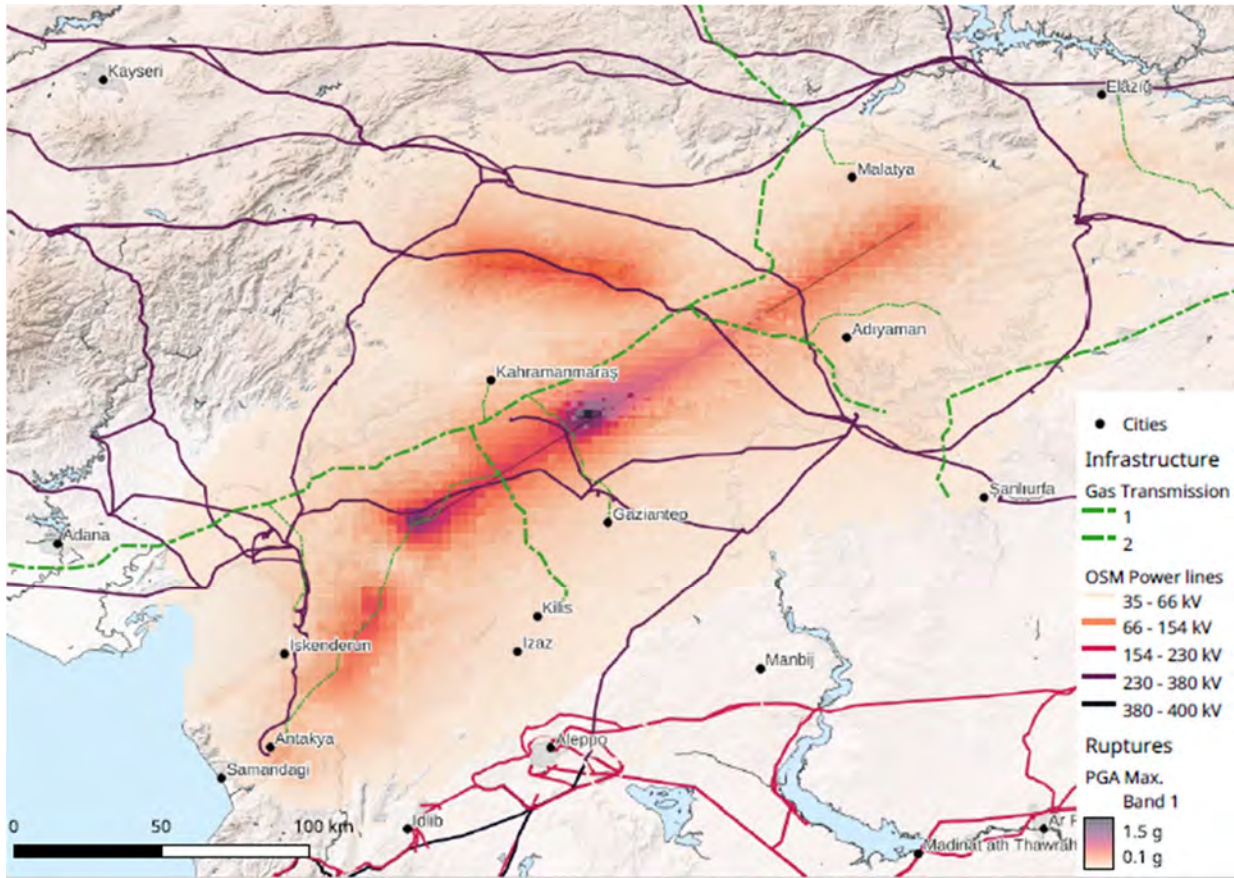
Figure 31: Locations of critical gas transmission and power lines (Source: Albert Kottke & Ozgur Kozaci)
